NATIONAL RESEARCH COUNCIL
CANADA
DIVISION OF BUILDING RESEARCH

TORNADO WIND DAMAGE TO BUILDINGS OBSERVED
AFTER THE SARNIA TORNADO
of May 21, 1953

by
J.D. McCrea
With a Supplement by D.C. Tibbetts

Report No. 111
of the
Division of Building Research

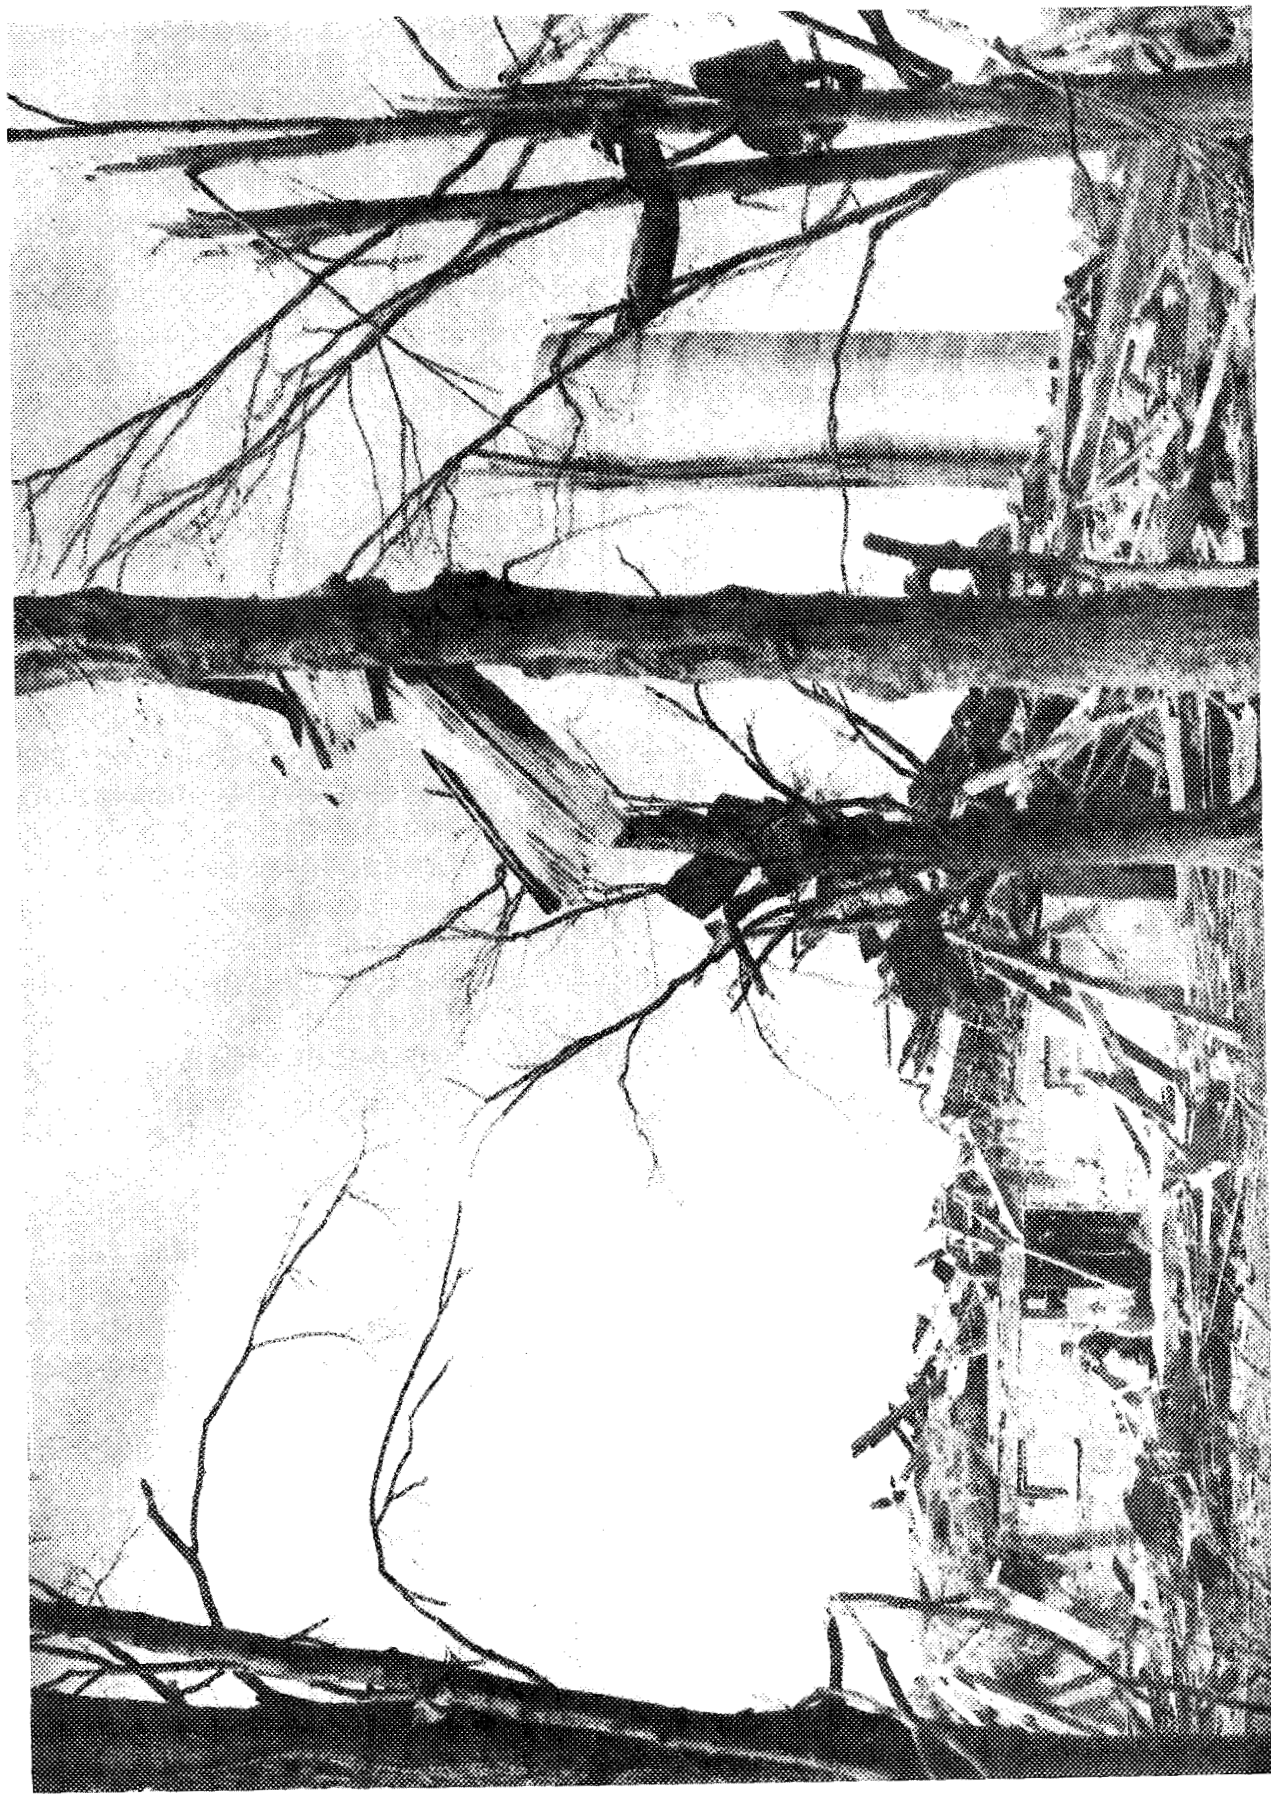
of the roots of many trees in Sarnia were pulled out when the trees toppled over, while the trees in the London Township district, in many cases, were broken off 5 to 10 feet above the ground (Fig.13). This seemed to indicate that the main differences in tree damage were due to a variation in the average ground water table levels in the two areas. The water table level was closer to the ground surface in Sarnia and thus the root penetration was not as deep as in the London Township. Of the two types, the failure at the roots necessitated more clearing up after the storm because generally the trunk had to be sawed off at the base before any clean-up operation could be started. This type of failure also caused considerable damage by breaking portions of the street surfaces, curbs, and sidewalks. Tree debris in the London Township could be cleaned up merely by pushing it aside.

It is interesting to note that silos withstood the full force of the tornado. On farms where demolition was otherwise complete, silos were left standing and apparently unaffected by the storm. It was not determined whether or not the tops of these structures were removed by the storm. If such was the case, the possibility exists that inside and outside pressures were equalized almost immediately and thus prevented collapse. The absence of failure in these silos may also be due, wholly or in part, to their cylindrical shape.

Figure 13 Damage to farm buildings and trees where silo is still standing
